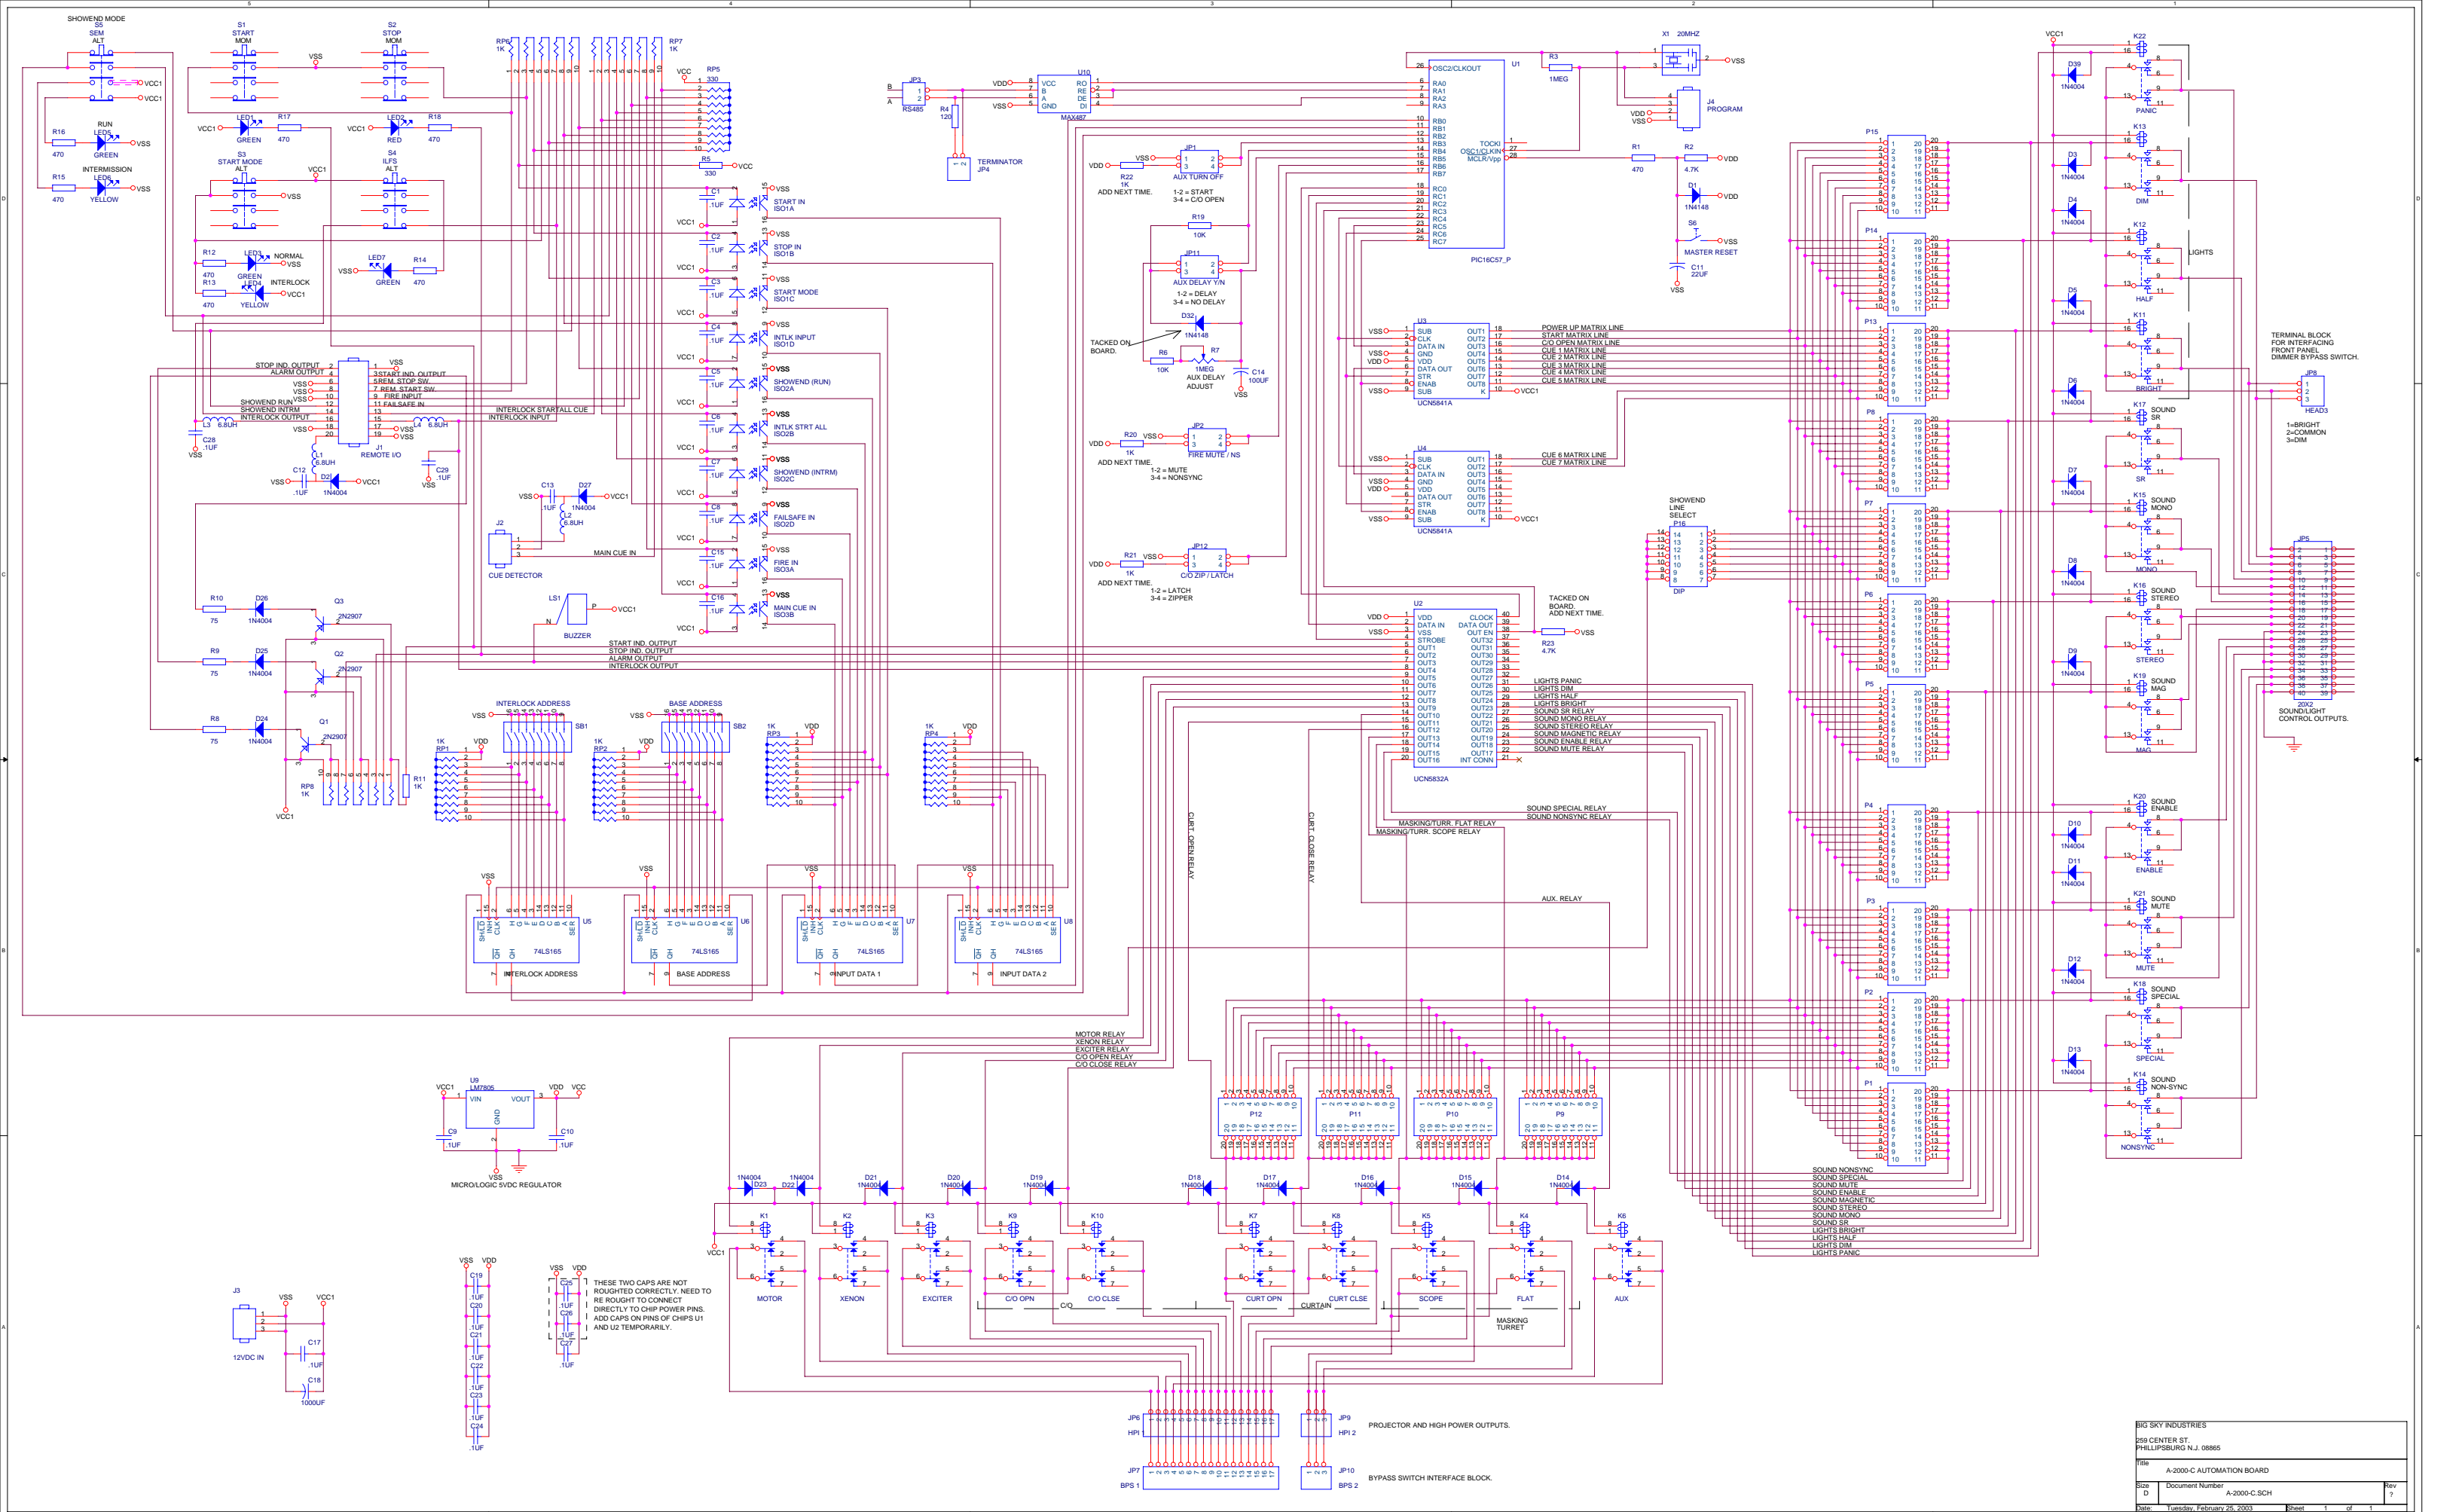
THESE TWO CAPS ARE NOT ROUTED CORRECTLY. NEED TO RE ROUTE TO CONNECT DIRECTLY TO CHIP POWER PINS. ADD CAPS ON PINS OF CHIPS U1 AND U2 TEMPORARILY.
